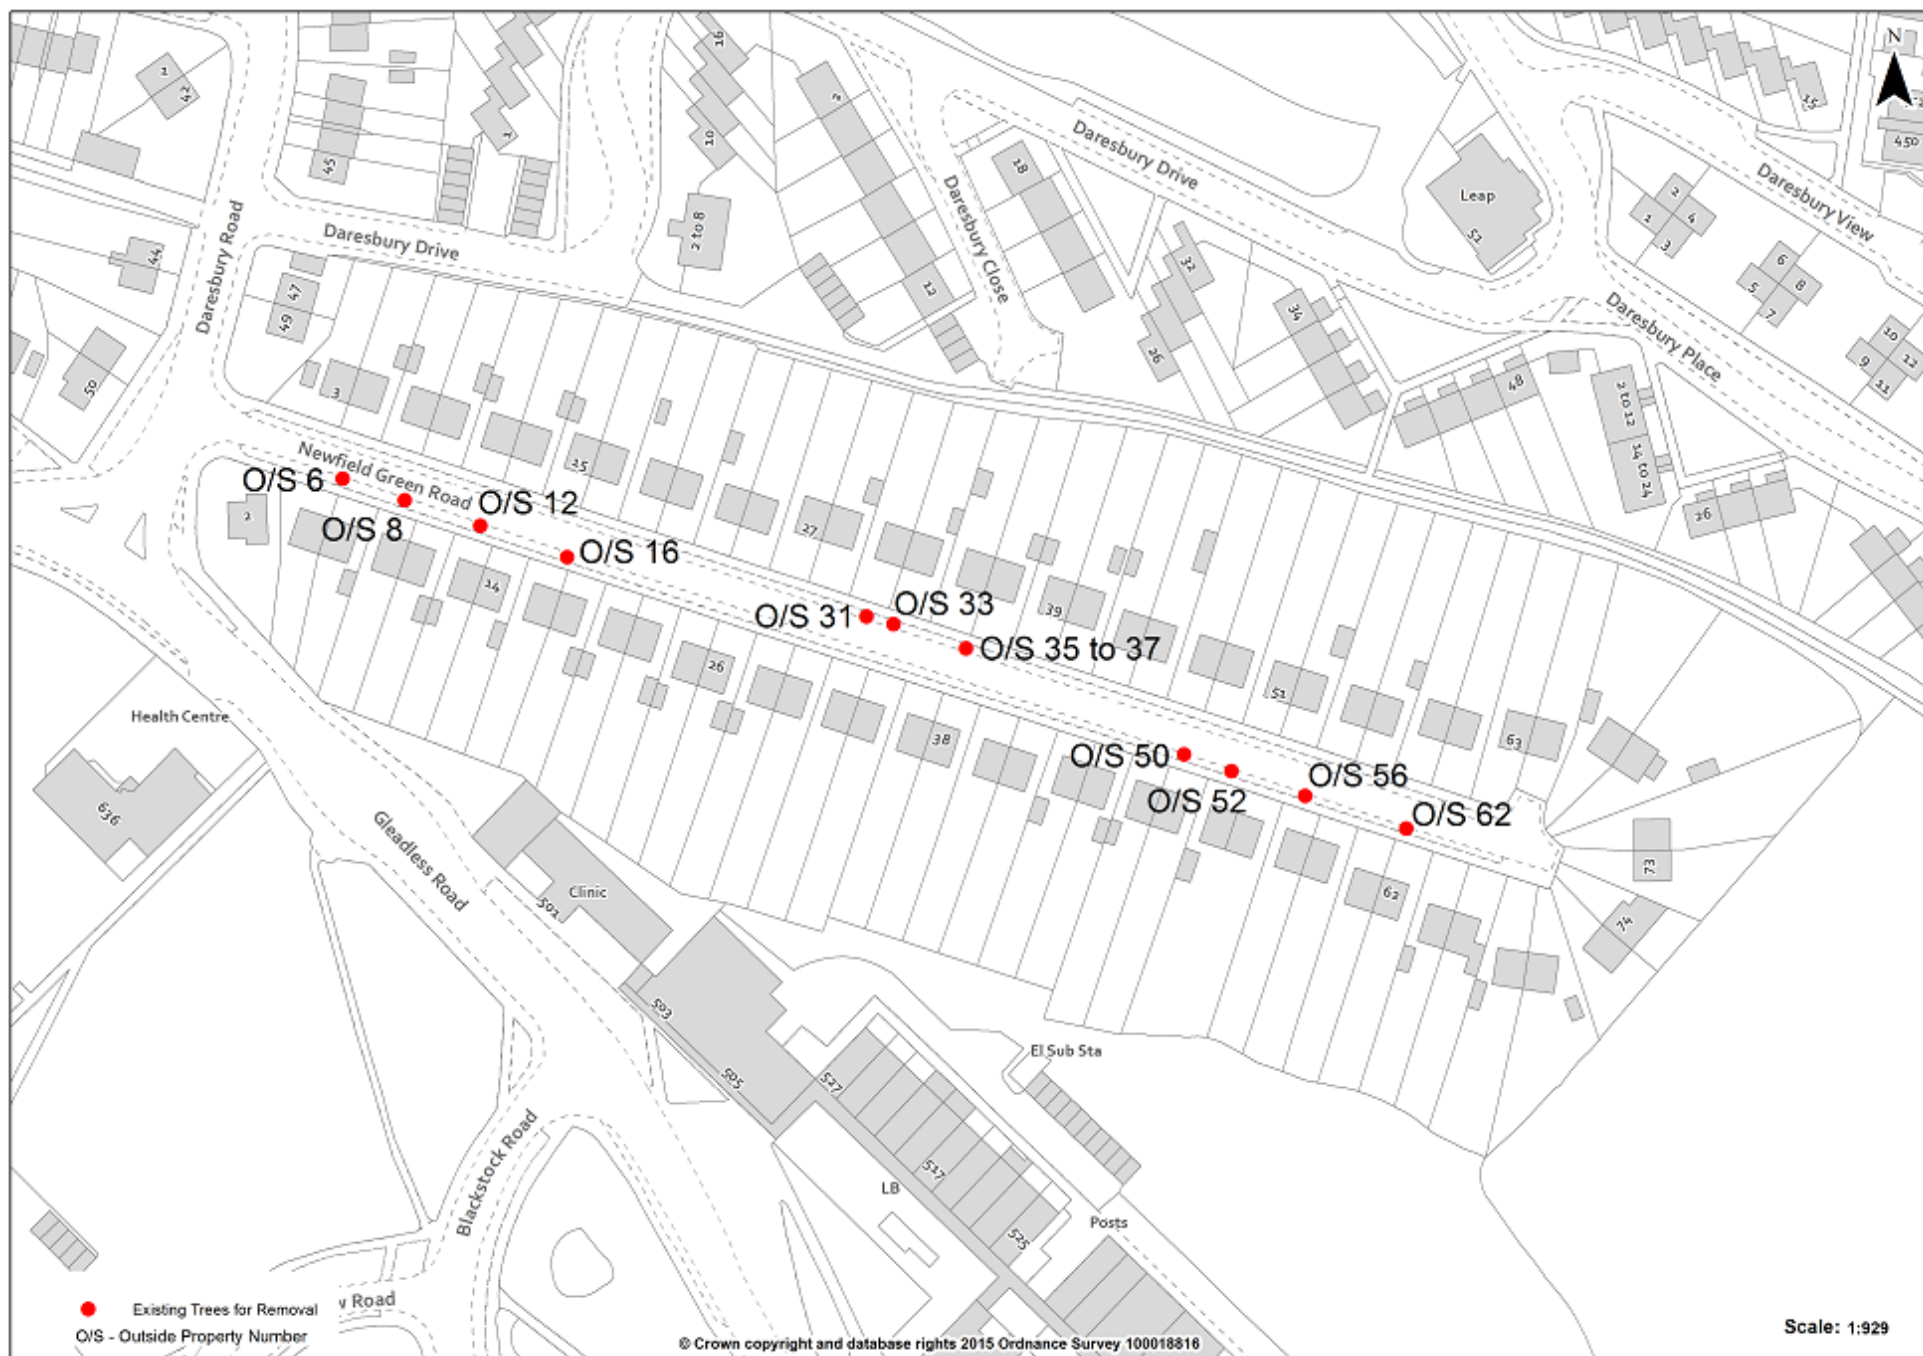
Site Name	Feature Location	6 D's	Reasons	Existing species	Planting notes	Replant species
NEWFIELD GREEN ROAD	o/s 8	TR: Felling: Senescent	Senescent - poor physiological condition	Prunus sp	Plant in verge o/s 8, (same as old tree)	Malus 'Evereste'
NEWFIELD GREEN ROAD	o/s 12	TR: Felling: Decay	Scaffold decayed, structural integrity in doubt	Prunus sp	Plant in verge o/s 12, (same as old tree)	Malus 'Evereste'
NEWFIELD GREEN ROAD	o/s 16	TR: Felling: Structural Integrity	Extensive stem gumosis, poor specimen	Prunus sp	Plant in verge between 16 to 18, (same as old tree)	Malus 'Evereste'
NEWFIELD GREEN ROAD	o/s 50	TR: Felling: Structural Integrity	Substantial decay of scaffold limb, poor structural condition	Prunus sp	Plant in verge o/s 50, (same as old tree)	Malus 'Evereste'
NEWFIELD GREEN ROAD	o/s 52	TR: Felling: Structural Integrity	Stem and scaffold branch decaying	Prunus sp	Plant in verge o/s 52, (same as old tree)	Malus 'Evereste'

NEWFIELD GREEN ROAD	o/s 56	TR: Felling: Structural Integrity	Stem gumosis and decay of scaffold	Prunus sp	Plant in verge o/s 56, (same as old tree)	Malus 'Evereste'
NEWFIELD GREEN ROAD	o/s 6	TR: Felling	Lateral root uplifting f/w	Prunus sp	Plant in verge between 4 to 6, (same as old tree)	Malus 'Evereste'
NEWFIELD GREEN ROAD	o/s 33	TR: Felling	Shallow rooting damaging f/w and potential 3rd party driveway claim	Prunus sp	Plant in verge o/s 33, (same as old tree)	Malus 'Evereste'
NEWFIELD GREEN ROAD	o/s 35 to 37	TR: Felling	Shallow rooting damaging, recent patch repair uplifting	Prunus sp	Plant in verge o/s- between 35 to 37, (same as old tree)	Malus 'Evereste'
NEWFIELD GREEN ROAD	o/s 62	TR: Felling	F/W disrupted by shallow rooting	Prunus sp	Plant in verge o/s- between 60 to 62, (same as old tree)	Malus 'Evereste'
NEWFIELD GREEN ROAD	o/s 31	TR: Felling	Basal bark damage, f/w obstructed by leaning stem	Prunus sp	Plant in verge o/s 31 (same as felled tree)	Malus 'Evereste'
